Safety Bulletin: Console plates of compensation cylinders TB270.4 (HV5), TB290.1 and TB300

date 09.01.2026	mod. pk	page 1	pages 1
		chk. tw		
	description	Safety Bulletin, English TB270.4 (HV5), TB290.1, TB300		
Drawing number 0927000100

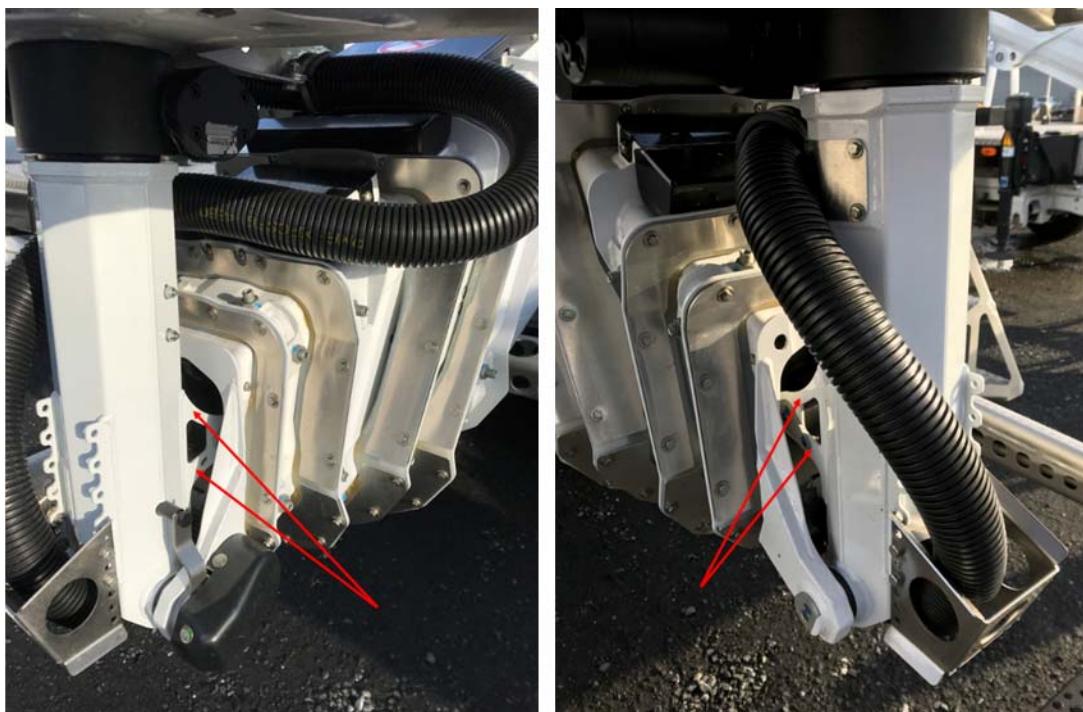
As part of our market monitoring, we have noticed that improper operation or accidents involving the Steiger TB 270.4 (HV5), TB 290.1 and TB 300 can lead to deformation/damage to the console plates of the basket leveling cylinder. These can be caused by overload, for example, by the basket colliding with an obstacle while the Steiger is being operated or by a traffic accident.

In rare cases, this damage is not detected during visual inspection, so that failure of the connection cannot be ruled out during continued operation.

For this reason, particular attention must be paid to the integrity of the console plates during the daily visual inspection of the machine by the operating personnel. The console plates are clearly visible in the transport position.

If there are noticeable deformations and/or cracks at the areas marked in the images, operation of the Steiger must be stopped and RUTHMANN Service contacted.
